MONROE SCHOOL DISTRICT

GYM BUILDING CAULKING ABATEMENT PLAN SKY VALLEY EDUCATIONAL CENTER

**SKY VALLEY
EDUCATIONAL CENTER**
351 SHORT COLUMBIA STREET
MONROE, WASHINGTON

POD/LIBRARY BUILDING
CAULKING ABATEMENT PLAN
SKY VALLEY EDUCATIONAL CENTER

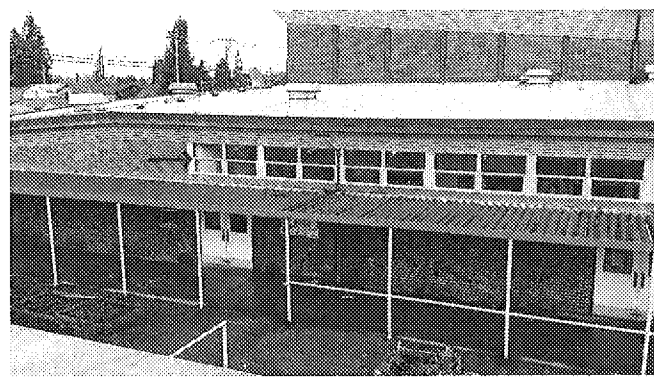
2 PHOTO DETAIL

2. REMOVE APPROX. 300 LF OF PCB-CONTAINING CAULKING ON THE EXTERIOR METAL WINDOW FRAMES ON ALL WINDOWS AT THE SOUTH AND WEST ELEVATIONS OF THE LARGE GYM BUILDING AS SHOWN. THIS INCLUDES CAULKING THAT EXISTS AROUND EACH WINDOW INFILL PANEL METAL FRAME TRANSITION ON THE WEST ELEVATION. THESE INFILL PANELS ARE CEMENT ASBESTOS BOARD.

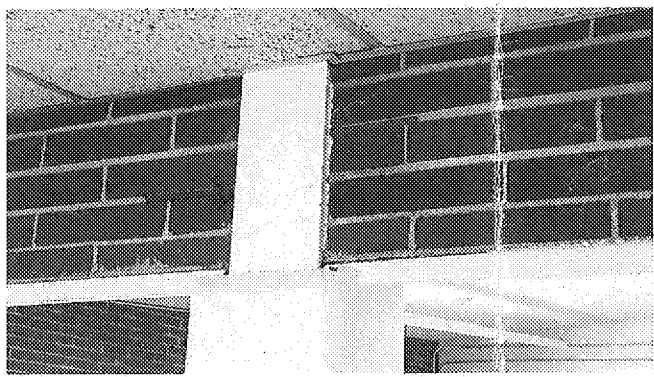
8 PHOTO DETAIL

8. REMOVE APPROX. 500 LF OF PCB-CONTAINING CAULKING LOCATED ON ALL VERTICAL STRUCTURAL METAL COLUMN TRANSITIONS THROUGHOUT THE EAST ELEVATION OF THE LARGE GYM AS SHOWN. THIS INCLUDES THE REMOVAL OF ALL CAULKING ON THE INTERIOR DEMISING WALL METAL BEAMS (VERTICAL AND HORIZONTAL) BETWEEN THE DAYCARE AND THE GATHERING PLACE/CAFETERIA AS SHOWN. THE CAULKING IS HEAVILY PAINTED THROUGHOUT THE WORK SCOPE AREA.

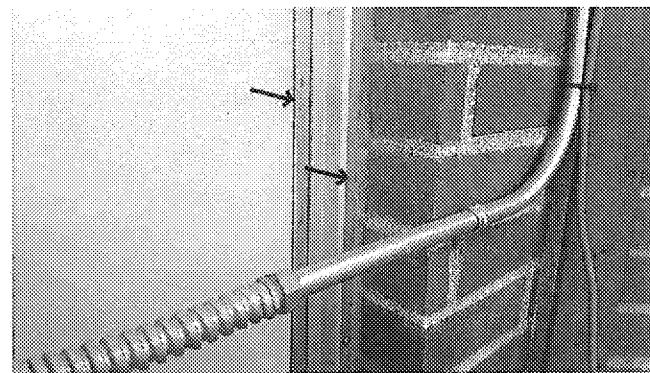
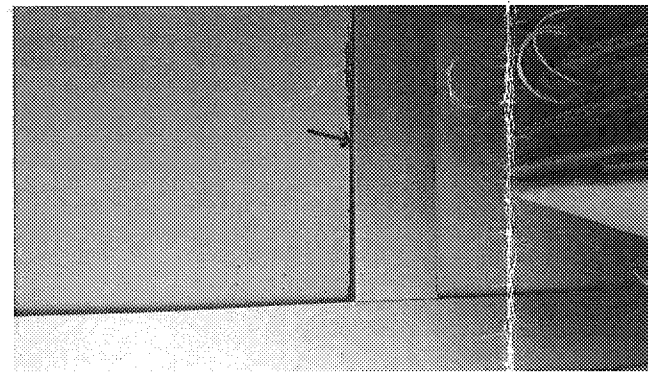
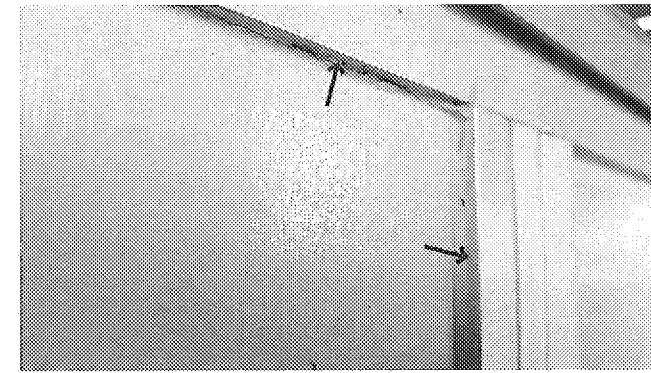
- ① REMOVE APPROX. 500 LF OF PCB-CONTAINING CAULKING LOCATED ON INTERIOR PERIMETER METAL WINDOW FRAME TO BRICK TRANSITION VERTICALS IN EACH OF CLASSROOMS 1-20 AS SHOWN.
- ② REMOVE APPROX. 1,400 LF OF PCB-CONTAINING CAULKING ON THE INTERIOR AND EXTERIOR SIDES OF THE CEMENT ASBESTOS BOARD (CAB) WINDOW INFILL PANELS. THE CAULKING FILLS THE GAP BETWEEN THE METAL WINDOW FRAME AND CAB TRANSITION IN EACH OF CLASSROOMS 1-20 AS SHOWN.

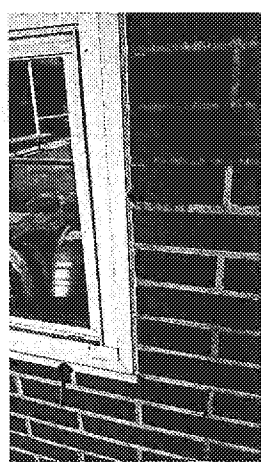
1 PHOTO DETAIL

1. REMOVE APPROX. 400 LF OF PCB-CONTAINING CAULKING LOCATED ON ALL INTERIOR METAL WINDOW SILL TRANSITIONS AND ALL EXTERIOR METAL WINDOW FRAME TRANSITIONS THROUGHOUT THE ADMINISTRATION BUILDING AS SHOWN.
2. REMOVE APPROX. 175 LF OF PCB-CONTAINING CAULKING LOCATED ON ALL EXTERIOR VERTICAL STRUCTURAL METAL BEAM TRANSITIONS THROUGHOUT THE ADMINISTRATION BUILDING AS SHOWN.
